# Buffers

# Case Study: Thedford-Klondyke Wind Storm

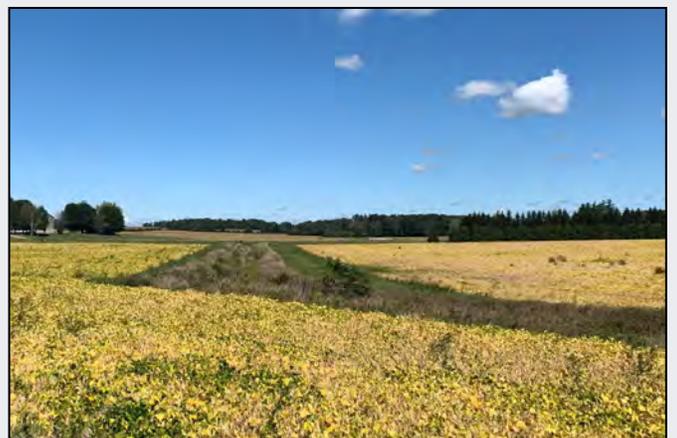
Buffers protecting both sides of the drain.

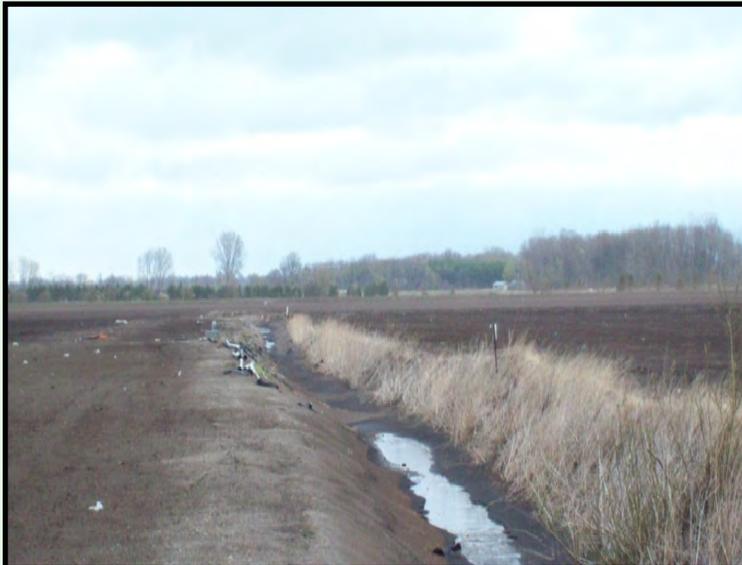
Lake Smith Drain No. 2— northeast of Greenway Drive. No vegetated buffer strip and topsoil entering and filling the drain.

High winds on April 23, 2012 resulted in what could be described as a dust storm. Sustained winds of 60 km/hr for a 12-hour period during the day easily transported the light soils through the air and over the ground surface. Municipal infrastructure was impacted significantly as drifts of soil covered roads, and within the fields, municipal drains were filling in steadily. While plows were able to keep the roads clear, many of the drains in the marsh were left without much defence. Soil was steadily flowing over the tops of the banks of the municipal drains, notably where buffers were not present. Some drains were completely filled in within 12 hours. The most stable and least impacted drains were those protected by well established vegetated buffer strips.

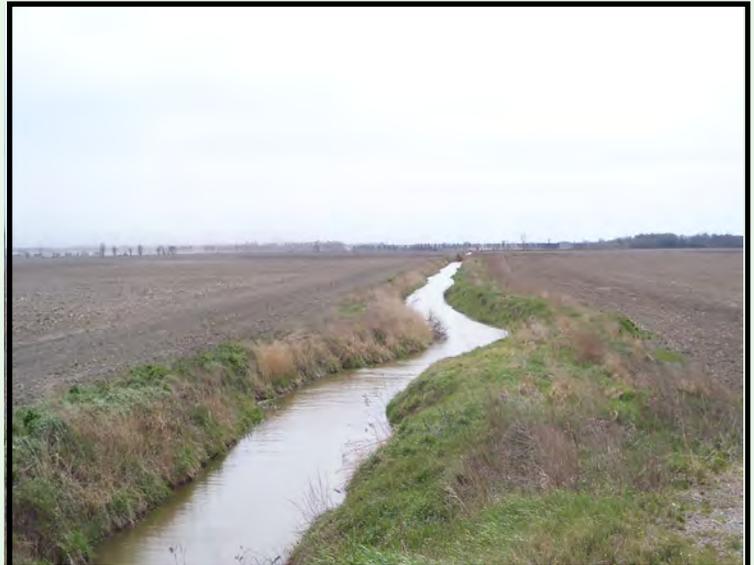
Lake Smith Drain No. 2 - View looking southwest from Greenway Drive: Vegetated buffer strip with minimal loss of topsoil to the drain.
